Non- Chromium Conversion Coatings on Aluminum

Israel Institute of Metals

Annual Report

Special Project No. SPC-98-4005

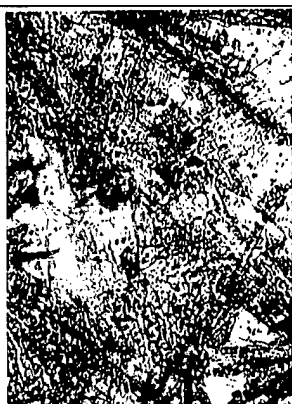
Without any
pretreatment

Pretreatment in
3 % SiO_2

Pretreatment in
1) 30 % H_3PO_4
2) 3% SiO_2

Fig. 14. Initial stage of zinc / phosphate coating growth. Deposition time 2 min.
Optical microphotographs. Magnification 200.

Several samples of Al 2024 T3 were treated in 30 % H_3PO_4 at 25 °C for 3 min, rinsed in water and immersed in a 3 % colloidal solution of SiO_2 at 25°C for 3 min. After that the samples were immersed in the phosphating solution and treated as usual. As can be seen in Fig. 14 the treatment in the colloidal SiO_2 solution contributed to the formation of faceted crystals.

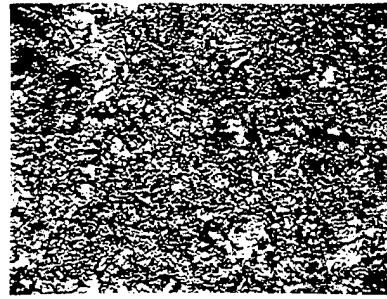
Fig.16. Structure of Al 2024 T3 surface before (a) and (b) after sand blasting. Optical microphotographs. Magnification 200.

Several Al 2024 samples were subjected to sand blasting and then treated as shown in Table 6. Sand blasting essentially increased roughness of the surface . The surface structure before and after sand blasting is shown in Fig. 16. The immersion of sand blasted samples in H_3PO_4 solutions resulted in very intensive etching process with an extremely

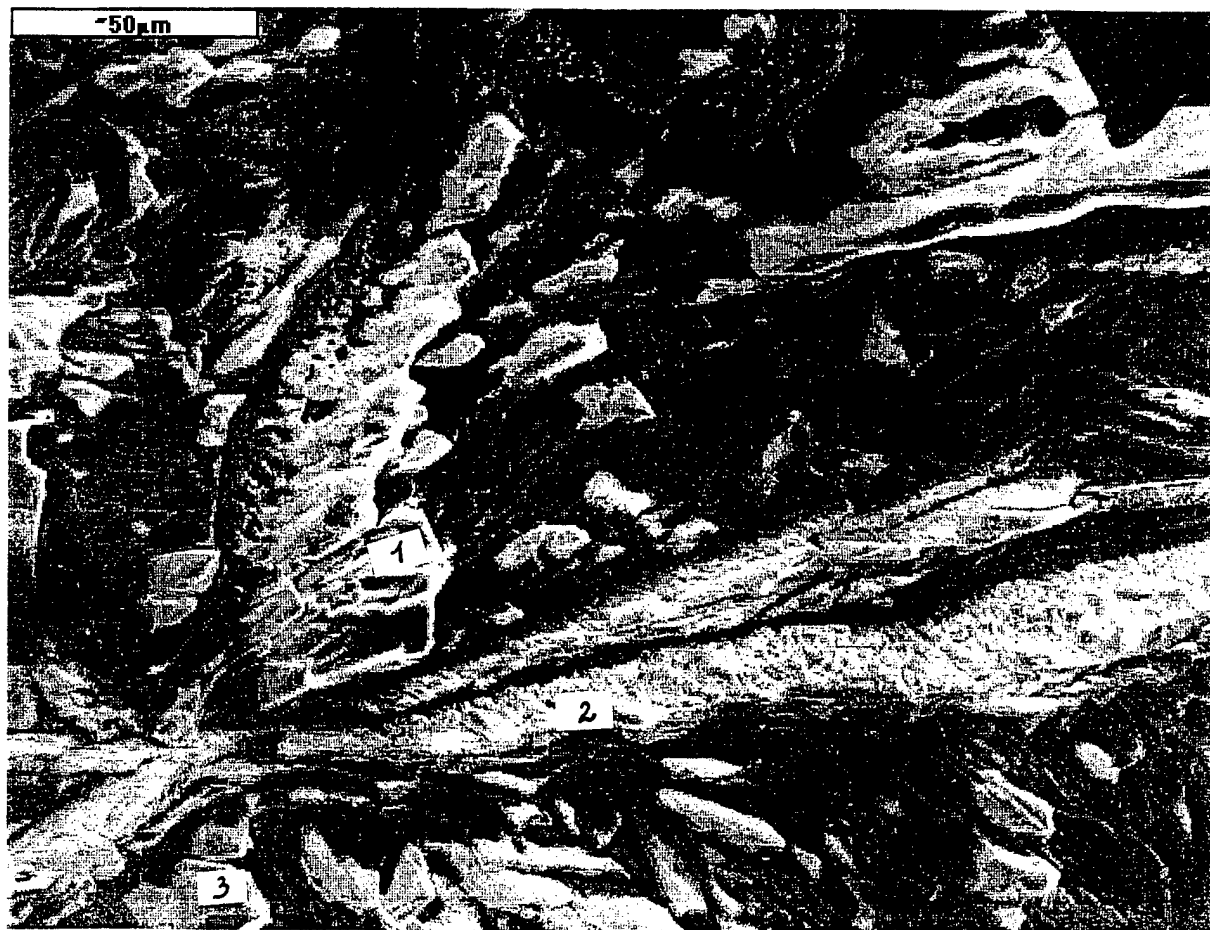
Spot	Zn / P / O
1	1.42 / 1 / 3.94
2	1.57 / 1 / 4.92
3	1.71 / 1 / 4.73

Fig.17. Surface morphology and composition of zinc/phosphate coating. Sample 234..
Magnification 500.

The composition the coatings was determined by EDS and XR analyses. The results of EDS analysis for two different samples are shown in Figs. 18,17. The crystals of different forms, namely, faceted and dendritic (star rays) had the same composition . The crystals consisted of Zn, P and O. The concentrations of these elements were about 22, 16 and 62 % (a.c.), respectively.

Zn / P / O ratios in Hopeite were 1.5 and 6.0, respectively. However, according to the EDS analysis these ratios ranged between 1.42 / 1 / 3.94 and 1.73 / 1 / 5.49. The reasons of the discrepancy in the results of EDS and XRD analyses should be investigated at the following stage of the work.

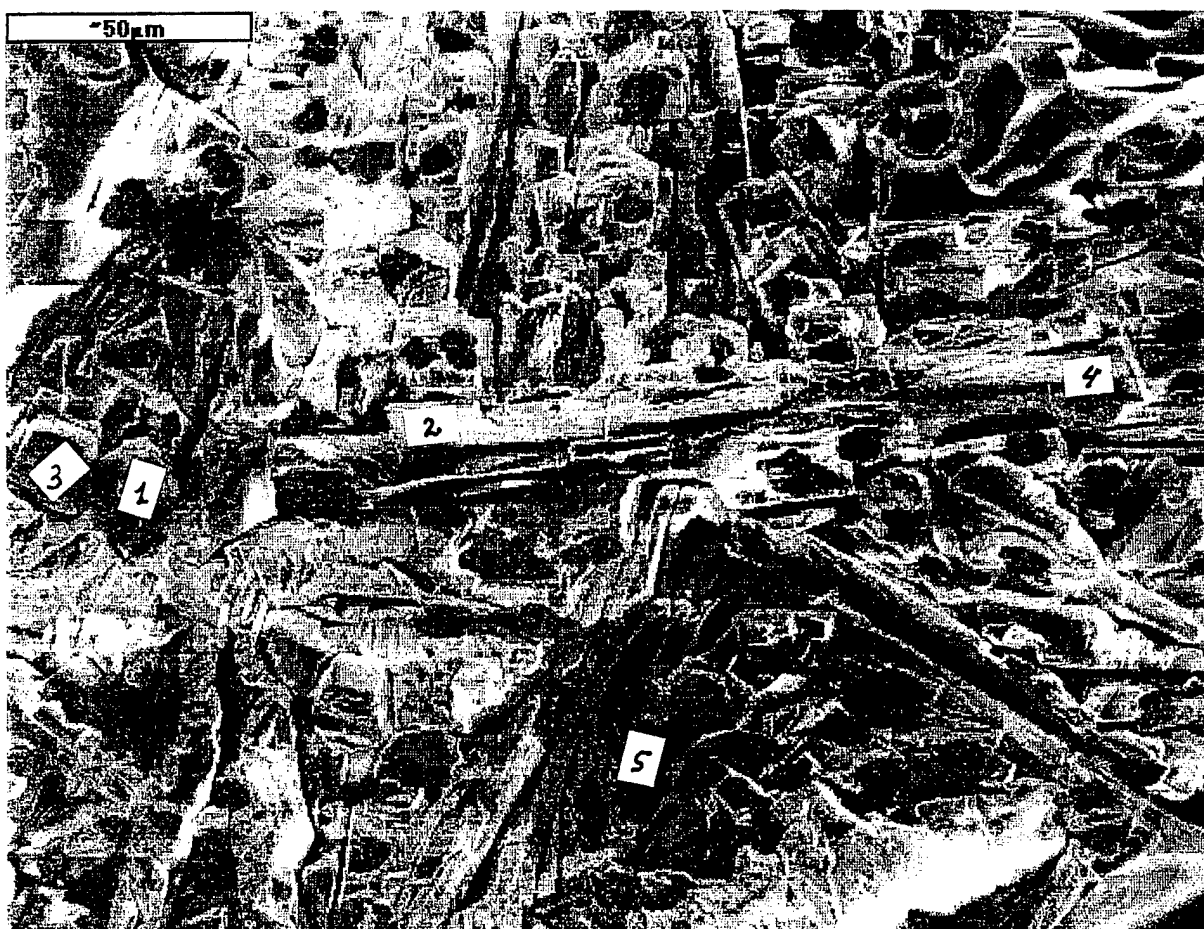
Spot	Zn / P / O
1	1.73 / 1 / 5.49
2	1.72 / 1 / 5.27
3	1.50 / 1 / 4.28
4	1.61 / 1 / 4.88
5	1.56 / 1 / 4.41

Fig.18. Surface morphology and composition of zinc/phosphate coating. Sample 240.
Magnification 500.
